SUMMARY

1420 Prairie Oaks Dr, St. Cloud, FL
34771
Abby Miller
08/23/2025

Brett Miller
InterNACHI Certified Home Inspector,
IFSAC Fire Inspector III, and Certified
Plans Examiner
New Beginnings Home Inspections
+19186067911
brettmiller321@gmail.com

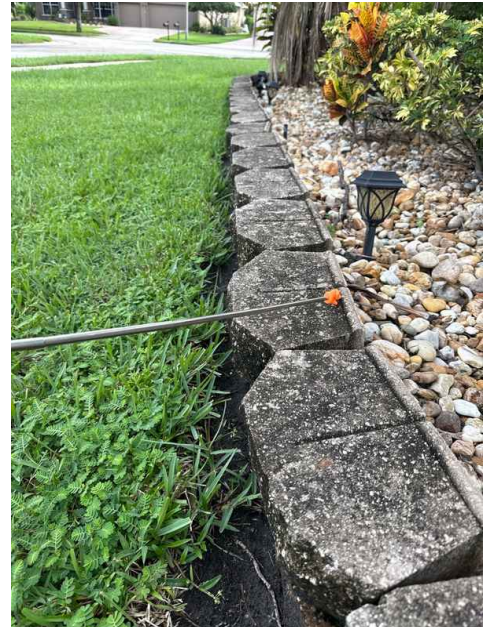
3.10.2 Vegetation, Surface Drainage, Retaining Walls, and Grading

RETAINING WALL DEFECT

I observed indication of a defect at the retaining wall.

The retaining wall blocks are upside down and the lip that holds in place is not seated. The retaining walls are all leaning out.

Correction and further evaluation is recommended.

Contact a qualified landscaping contractor

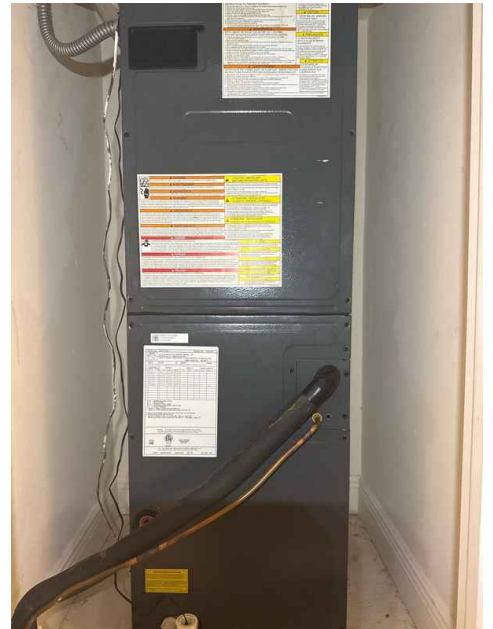
6.3.2 Cooling System

SERVICE TAG INDICATES DELAYED MAINTENANCE

I observed indications of delayed maintenance at the cooling system, because of the date of the most recent service on the service tag. The system should be cleaned and inspected by a HVAC professional every year. Correction and further evaluation is recommended.

Contact a qualified heating and cooling contractor

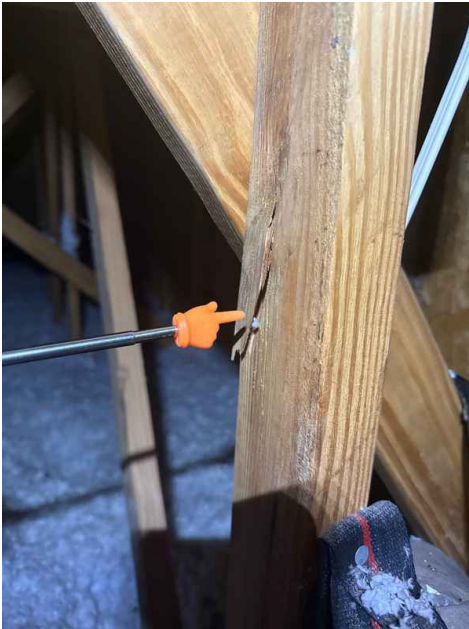
9.1.1 Structural Components & Observations in Attic

STRUCTURAL DEFECT IN ATTIC

I observed a major structural defect in the attic.

Contact a qualified carpenter.

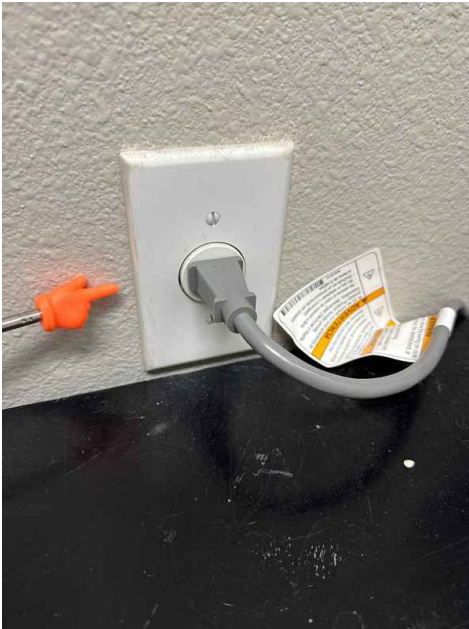
12.1.1 Clothes Washer

MISSING GFCI PROTECTION IN LAUNDRY

I observed missing GFCI protection for all receptacle outlets in the laundry, as it is required by standards.

Contact a qualified electrical contractor.

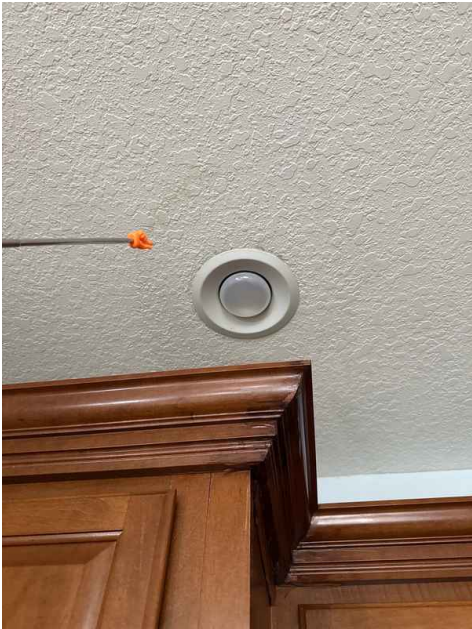
13.5.1 Floors, Walls, Ceilings **MOISTURE DAMAGE**

Stains on the walls visible at the time of the inspection appeared to be the result of moisture intrusion. The source of moisture may have been corrected. Recommend further examination by a qualified contractor to provide confirmation.

Contact a qualified professional.
